Fire Performance of Interior Ceiling Grid Assembly

Indicative testing conducted following a modified test methodology described in UBC 26-3, Room fire test standard for interior of foam plastic systems

**Advanced Technology Inc.
6106 West Market St.
Greensboro, NC 27409**

WFCi Report #19041

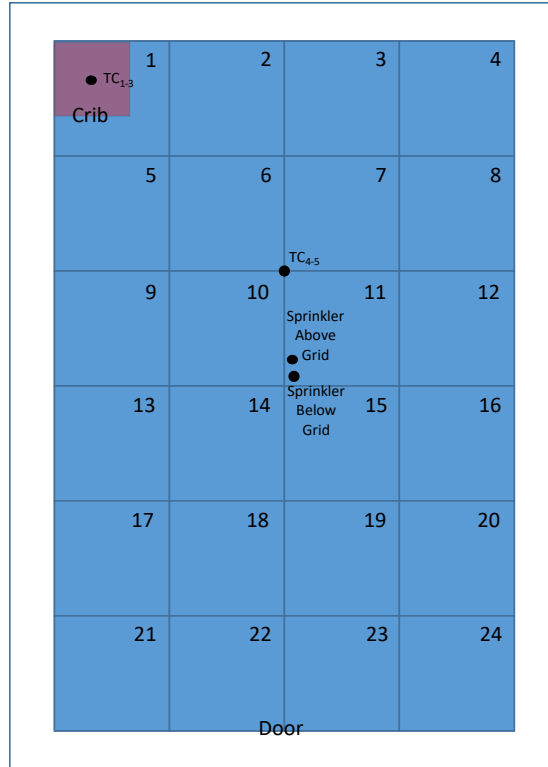
The room was instrumented with thermocouples (TC, Figure 1) that recorded temperature throughout the testing process. Three TCs (TC₁₋₃) were placed just above the burner at 3', 5', and 7' from the floor, respectively. Additional TCs were placed at 4' from the back wall and 4' for the side walls, one (TC₄) 1" below the ceiling grid and one (TC₅) 1" below the ceiling in the cavity above the grid.

Figure 1. Grid schematic for ceiling.

numbered according to Figure 1. A 2" hole was placed in tile #11 to allow for the sprinkler to protrude through the ceiling and allow the tile to freely fall when exposed to heat.

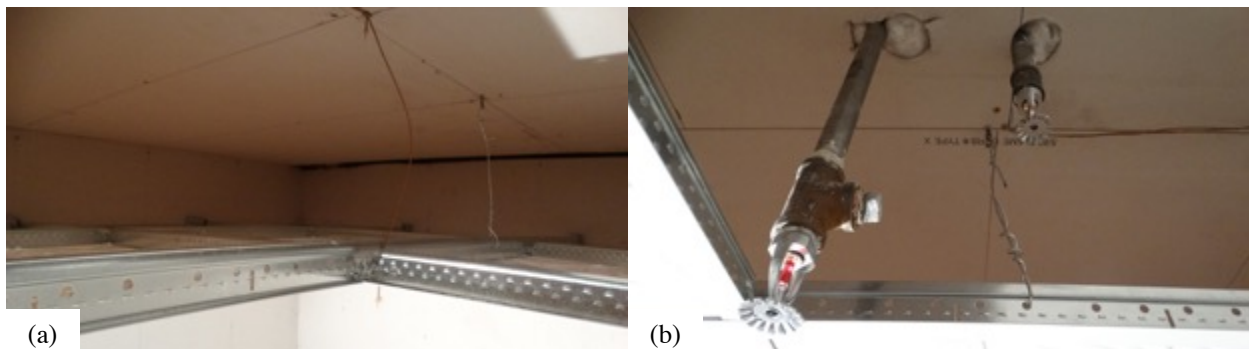
Figure 2. Room/corner images showing (a) cavity extension and (b) sprinklers below and inside cavity.

Two separate sprinklers (Tuna UL Listed ½ NPT, Standard Response) were located at the center of the room, one just below the ceiling grid and one inside the cavity above the ceiling. The operating pressure of the water for the sprinklers was 15 psi, well above their operating minimum (7 psi). The grid panels are designed to fall from the ceiling when exposed to heat, allowing heat accumulation to activate the higher sprinkler in the ceiling cavity.

The room construction was a standard 8'×12'× 8' wood stud construction. The interior of the room was covered with 5/8" type X gypsum. This modified version set the grid material at 8' from the floor, but the cavity above it extended an additional 1', also lined with 5/8" type X gypsum.

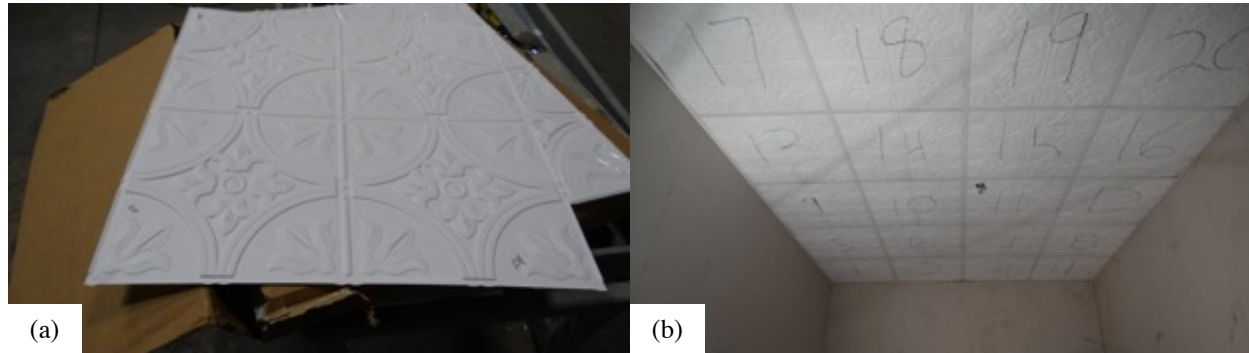
At the 8’ height in the room/corner assembly, an Armstrong Prelude ML 15/16 steel grid was installed in the 8’×12’ ceiling with 2’×2’ grid spacing. With the grid system in place, ATI Decorative Laminates “Mirroflex” ceiling tiles (0.013” thick, White PVC) were installed and

Figure 3. Tile images showing (a) 2'x2' tile and (b) installed ceiling.

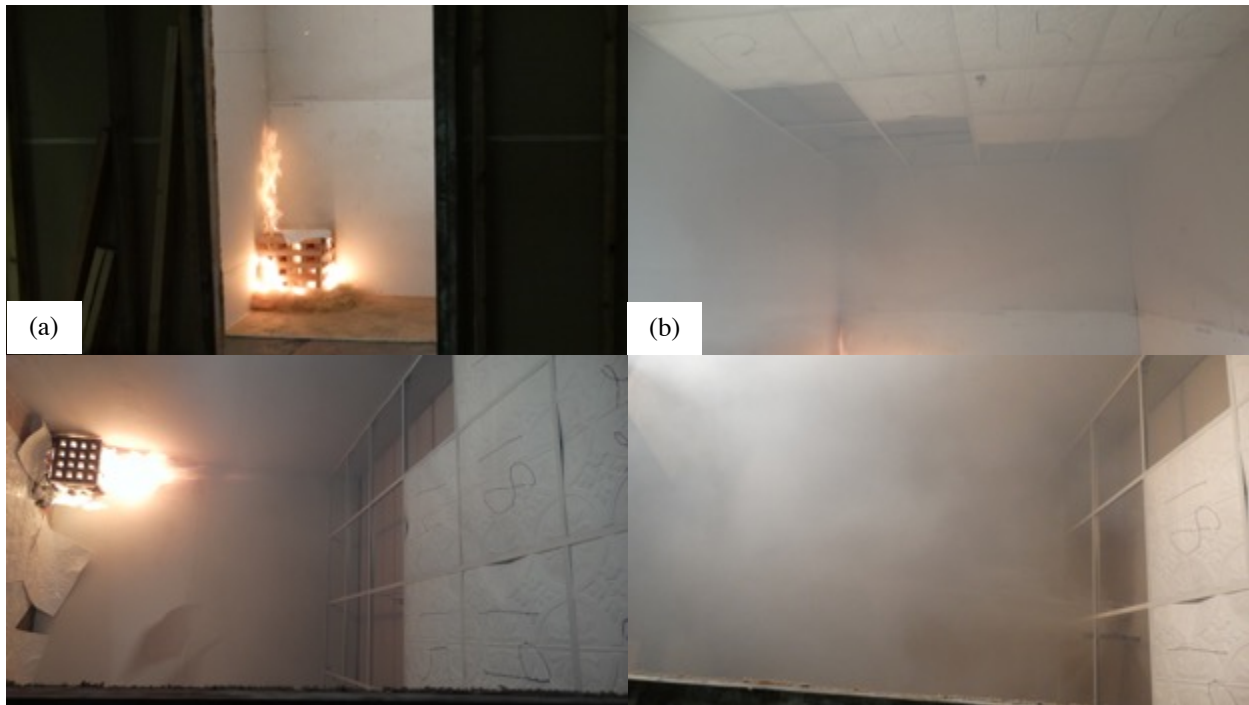
The crib was ignited to begin the test ($t = 0$ s). Once the tiles heated up, they began to fall from the grid system and the time they fell is shown in Table 1. The upper sprinkler (in the ceiling cavity) activated at 1 m 30 s into the test, cooling the room. The water accumulated so the test could not be continued beyond 2 min, after which the test was terminated. Sixteen (16) of the 24 tiles had fallen during the test, primarily the ones closer to the wood crib. The lower sprinkler (below the ceiling grid) never activated. The fallen tiles did not appear to burn significantly other than those that fell right next to the wood crib.

Figure 4. Test 1 showing (a) crib ignition – 19 s, (b) fallen tiles – 69 s, (c) continued fallen tiles – 89 s, and (d) activated sprinkler – 99 s.

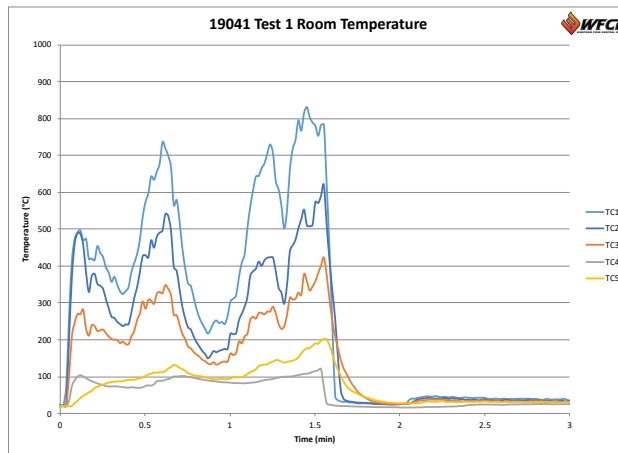
Figure 5 shows the various TCs recorded above the burner, at the ceiling, and in the ceiling cavity. The TCs above the burner (TC1-3) showed varying temperatures ranging between 200°C and 800°C before the ceiling cavity sprinkler activated cooling the room. The ceiling TC (TC4) initially rose to 100°C, but the ceiling cavity TC (TC5) soon (within 15 s) surpassed the ceiling TC once tiles started falling. The ceiling cavity TC reached approximately 200°C when the sprinkler activated.

Figure 5. Test 1 temperature data.

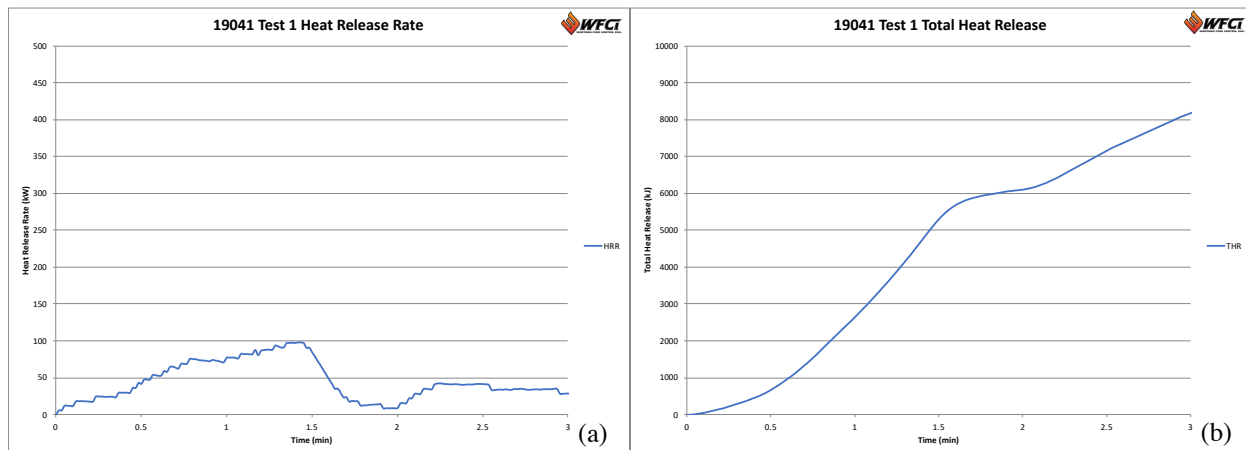
Figure 6 shows the heat release data obtained from the hood calorimeter during the test. As the wood crib and excelsior started burning, the heat release gradually increased to approximately 100 kW before the cavity sprinkler activated at 1 m 30 s. The total heat release reached approximately 5500 kJ when the sprinkler activated.

Figure 6. Test 1 data for heat release (a) rate and (b) total for the test.

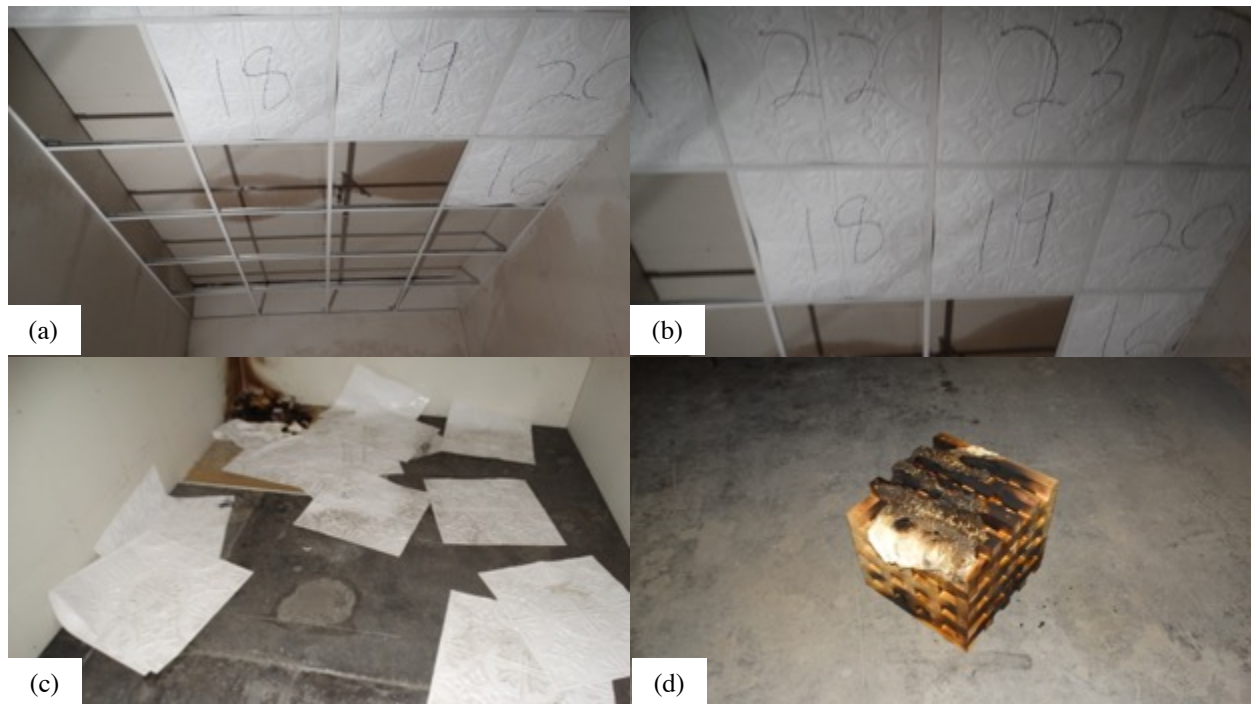
The first ceiling tile directly above the wood crib (#1) fell within 5 s after igniting the burner and it fell directly on the crib (Figure 7), which started to melt and burn during the test. Other ceiling

tiles fell in the vicinity of the crib, but they did not flame significantly. Some melting did occur to those that fell closest to the crib (~1'). Two-thirds of the tiles had fallen during the test before the cavity sprinkler activated.

Figure 7. Test 1 post-test images showing (a-b) remaining ceiling tiles, (c) fallen tiles, and (d) removed crib.
